Release Notes Programming

Passenger Cars

ISTA	4.20.2x
ISTA Service Data	4.20.20
ISTA/P	3.67.0

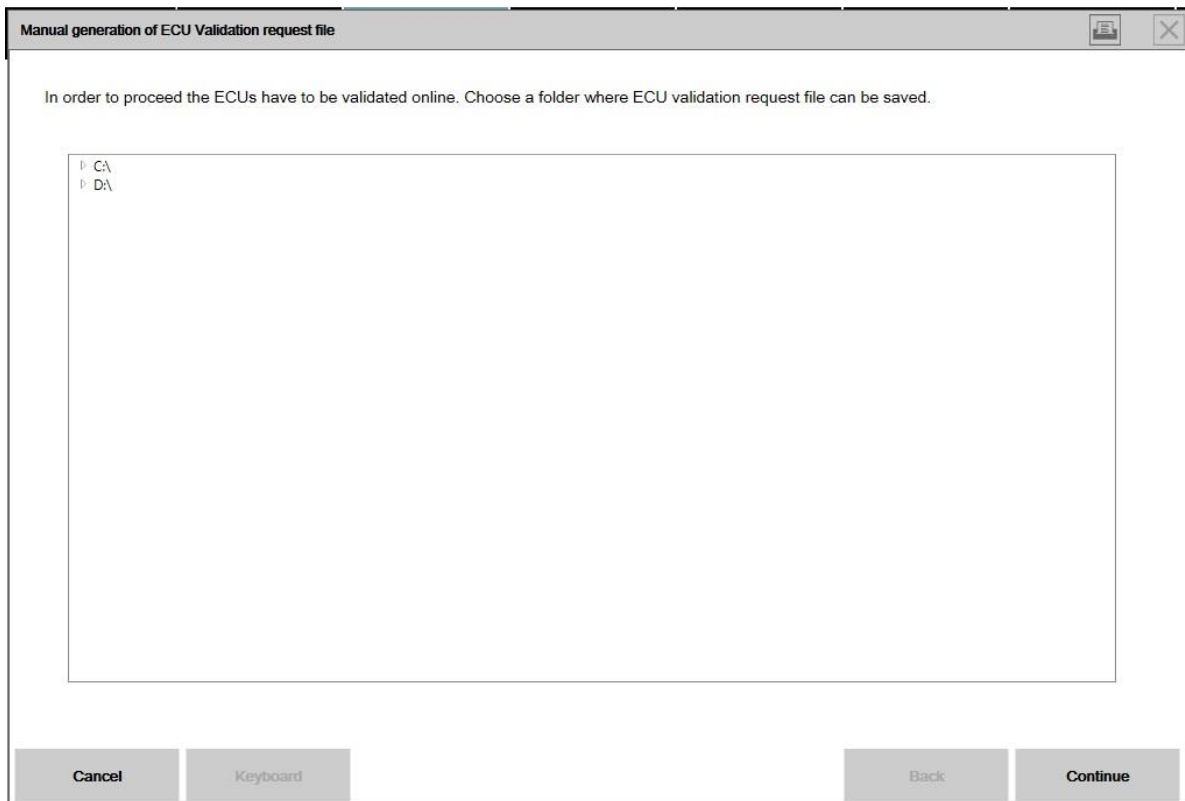
3. By clicking on the "Next" button, ISTA generates the required ValidationRequest_VIN_xxx.json.zip file and opens a file dialogue to save it. The file must be sent to technical support later via PuMA.

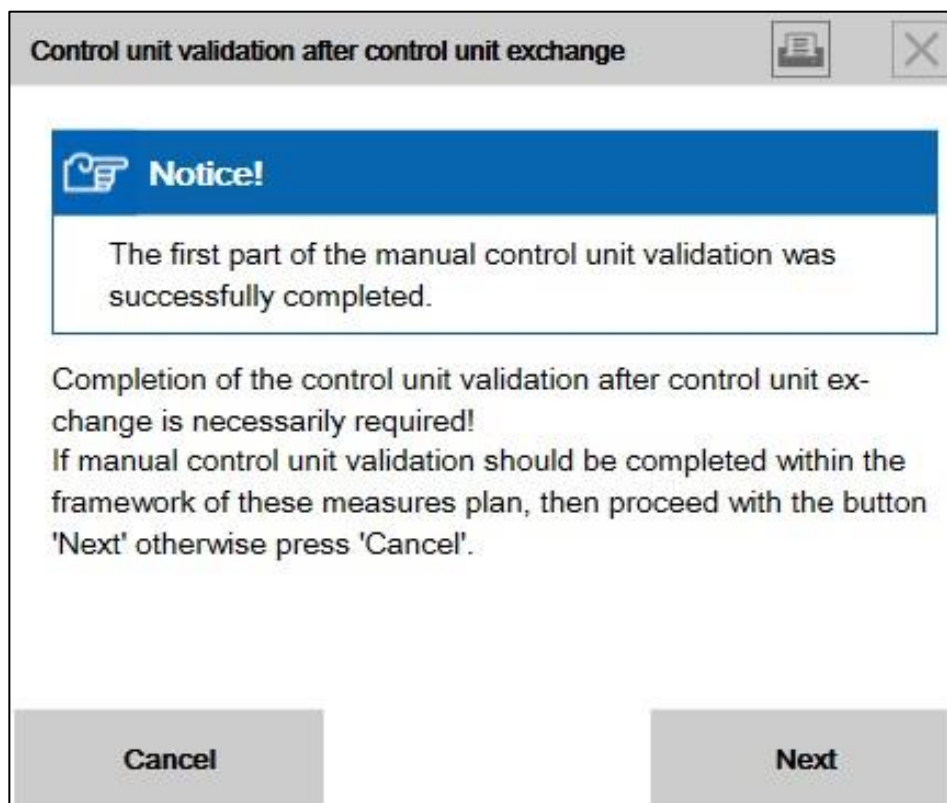
4. ISTA displays a note confirming that the file was successfully saved. At this point, you can exit the process using the "Cancel" button. After processing the measures plan, the session can be closed.

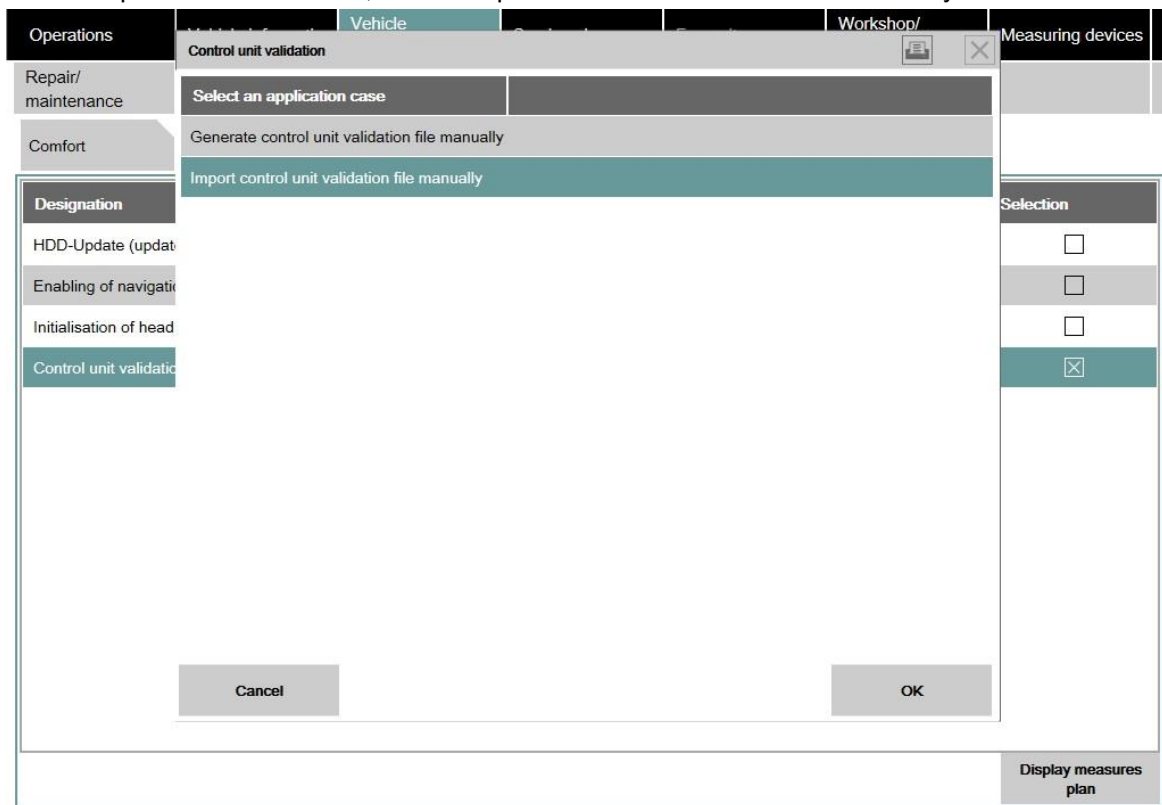
8. In order to import the validated file, select "Import control unit validation file manually" and confirm with

"OK".

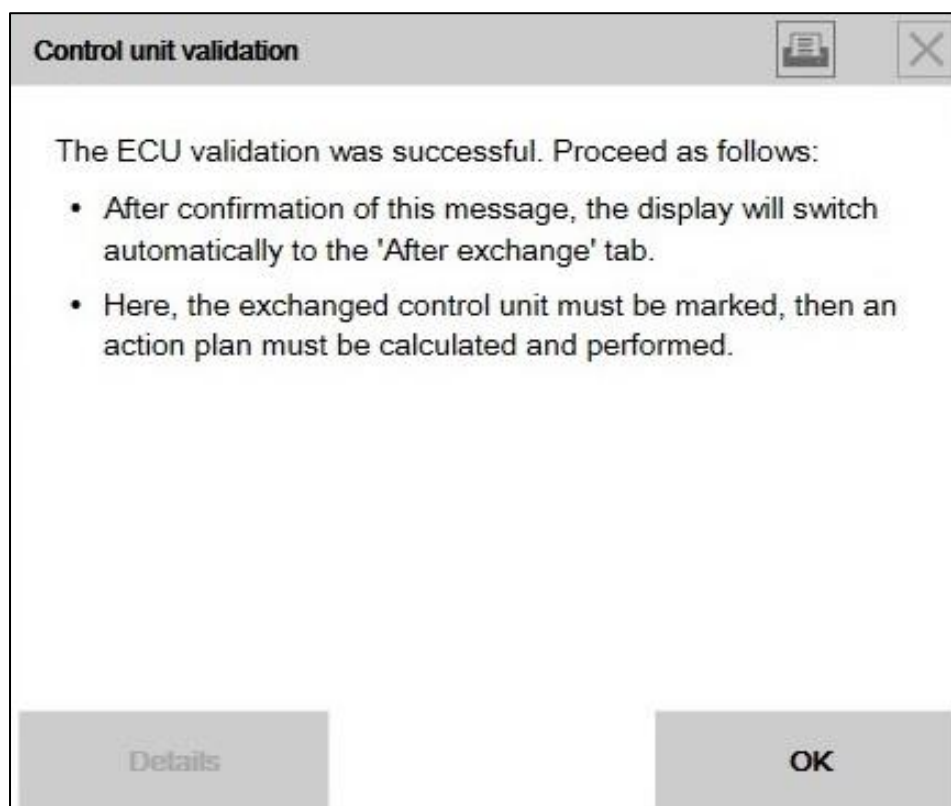
10. The file is written into the vehicle and checked.

11. After confirming the note, ISTA displays the tab for control unit exchange. Select the exchanged control unit and calculate and work through the measures plan.
