Report Number: 130681

**Re: Warning Letter, Operational Certificate 15821**

## Attachment 1: Site Inspection Photo Record

Onsite Inspection Date: June 11, 2019

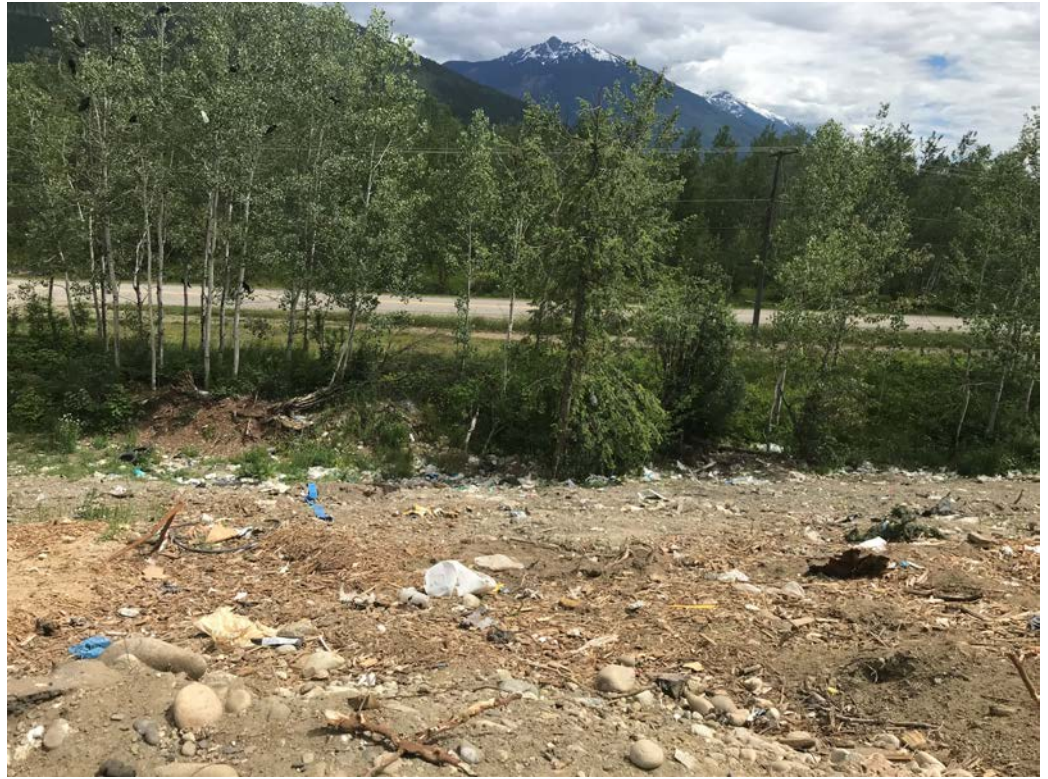
Photo 1

Litter on the east side slope of the landfill.

Compliance:	Out
Actions to be taken:	<p>Ensure that additional litter control measures are implemented at the Site that may include, but are not limited to, the application of sufficient intermediate cover, litter control fencing, or, if necessary, more frequent litter pickups.</p>
Requirement Description:	<p><b>3. OPERATIONAL REQUIREMENTS, 3.9 Waste Reduction and Alternate Disposal</b></p> <p>3.9: The Provincial Government has developed policies to promote the reduction, reuse and recycling of wastes. The Operational Certificate holder is encouraged to segregate for recycling and reuse, where possible, materials destined for disposal at this site. Public scavenging shall not be permitted at the landfill. The controlled salvaging of waste by the landfill operator or persons authorized by the Operational Certificate holder is encouraged if areas or facilities for separation and storage of recyclable or reusable materials are provided. In certain landfill environments, some construction and demolition debris or other wastes may create specific air and water quality concerns. If problems arise at this site that are attributable to specific wastes, the Director may require that alternate disposal/storage procedures be implemented.</p>

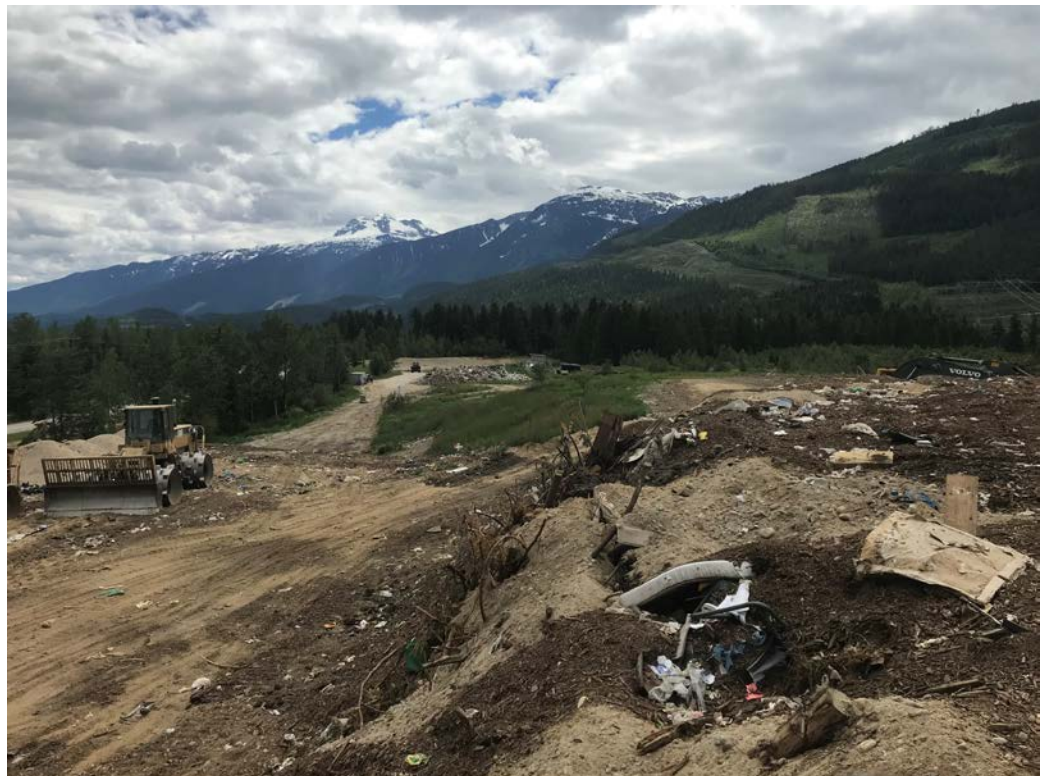
Photo 2

Details/Findings:	Ministry staff observed exposed waste on east (Photo 2) and west (Photo 3) slopes of the landfill, indicating insufficient intermediate cover was being applied. Insufficient intermediate cover was also evident by the excessive amount of litter observed at the Site. Therefore the CSRD is out of compliance with the requirement to meet or exceed the requirements of the BC Landfill Criteria or its most current version for daily, intermediate and final cover.  Ministry staff observed the working face to be small and manageable at the time of the inspection.
Compliance:	Out
Actions to be taken:	Ensure waste deposition and compaction meets the requirements of the most current version of the Landfill Criteria for Municipal Solid Waste for daily, intermediate and final cover.

Exposed waste on the east side slope of the landfill.

Compliance:	Out
Actions to be taken:	Ensure that sufficient intermediate cover is applied such that waste is covered and litter is reduced to minimized the presence of vectors at the Site.
Requirement Description:	<p><b>3. OPERATIONAL REQUIREMENTS, 3.6 Site Access and Supervision</b></p> <p>3.6: A landfill operator that has received BC Qualified Landfill Operator training, is familiar with the requirements of the Operational Certificate and the specifications of the Design and Operations Plan, shall be present at all times during operating hours. Locking gates shall be maintained at all access routes to the landfill site. Gates, perimeter fencing and/or barriers shall be installed where necessary to prevent unauthorized access to the site by vehicles. Gates shall be locked during non-operating hours.</p>
Details/Findings:	<p>Mr. Walker informed Ministry staff that the supervisor of the contracting company operating the landfill is certified as a landfill operator and has undergone the BC Qualified Landfill Operator training. However, Mr. Walker stated that the supervisor is not present at the Site at all times during operating hours and that it was not uncommon for the contractor's machine operators, who are not certified as a landfill operator and have not undergone the BC Qualified Landfill Operator training, to be the only personnel on-site. Therefore, the CSRD is out of compliance with this requirement.</p> <p>Ministry staff observed that the Site's access points are restricted by locking gates, which Mr. Walker stated were closed and locked during non-operating hours.</p>

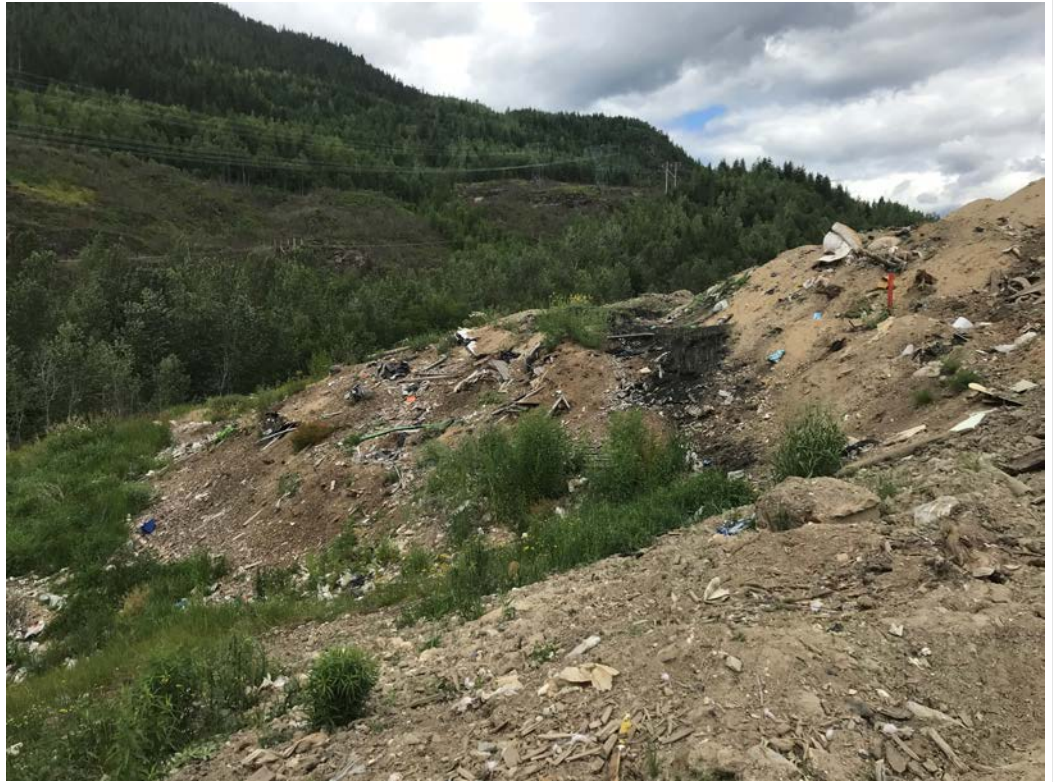
Photo 3

Litter on the west side slope of the landfill.
