ONLY THE BRAVE

David Fletcher remains vexed by the turretless but surprisingly versatile Ram Kangaroo personnel carrier

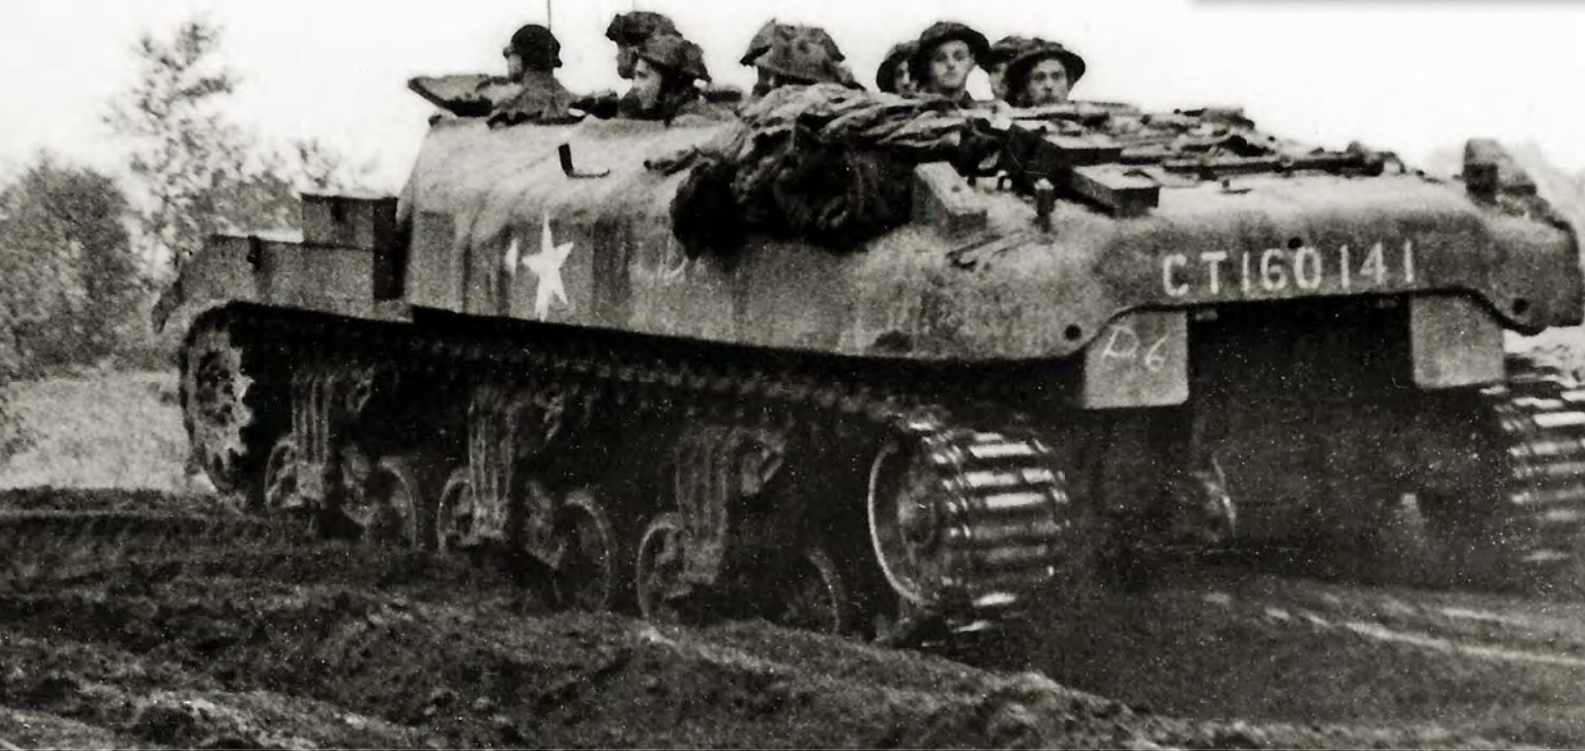
Below: A RAM Kangaroo, loaded with troops, advancing into action, even the hull machine-gunner is sitting with his head out so they are in no danger – yet.

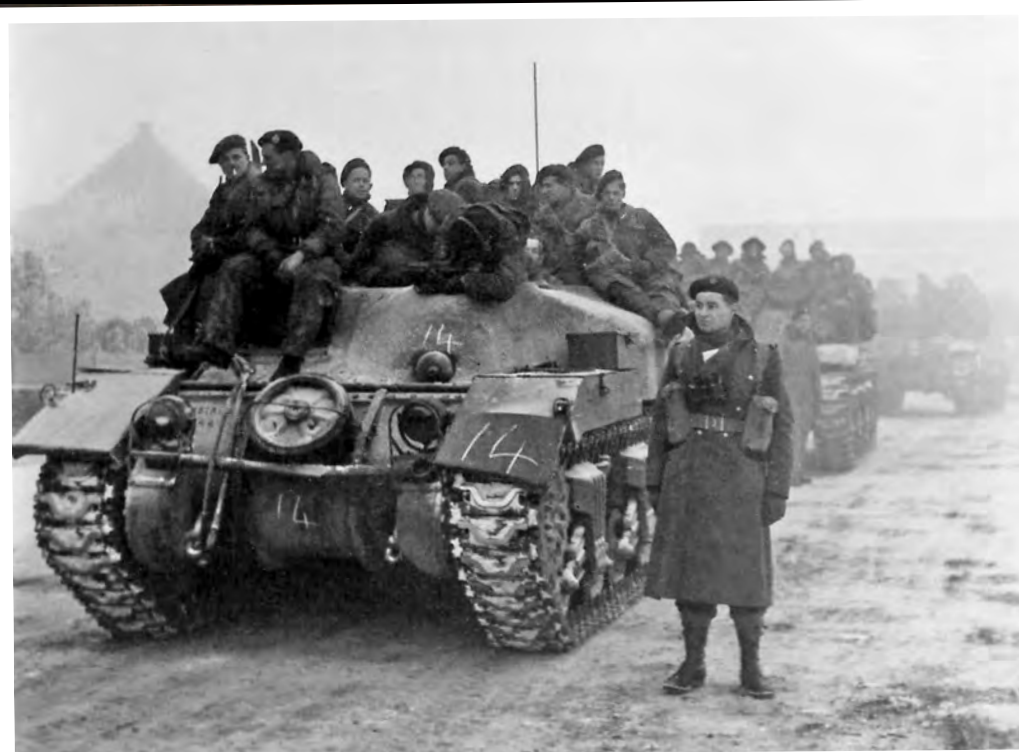
Photographed in very chilly conditions, Canadian RAM Kangaroos looking rather overloaded as they wait to go into action.

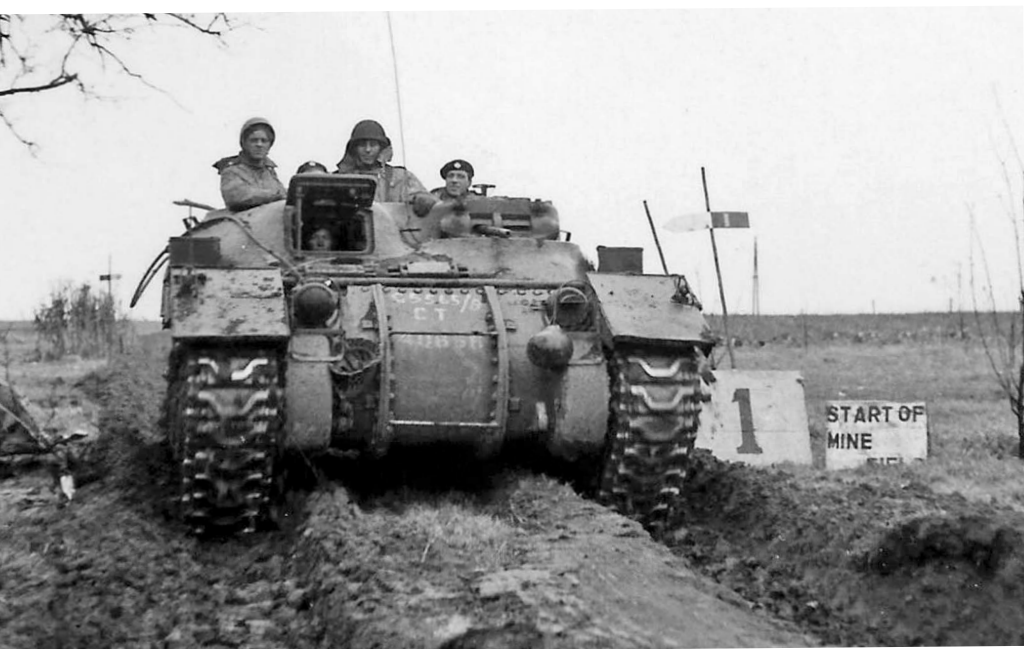
Above: A turreted Kangaroo, as used by 49RTR, sitting on the start line ready to move into action. Below: Infantry climbing aboard Kangaroos in a convoy. They are not finding it easy.

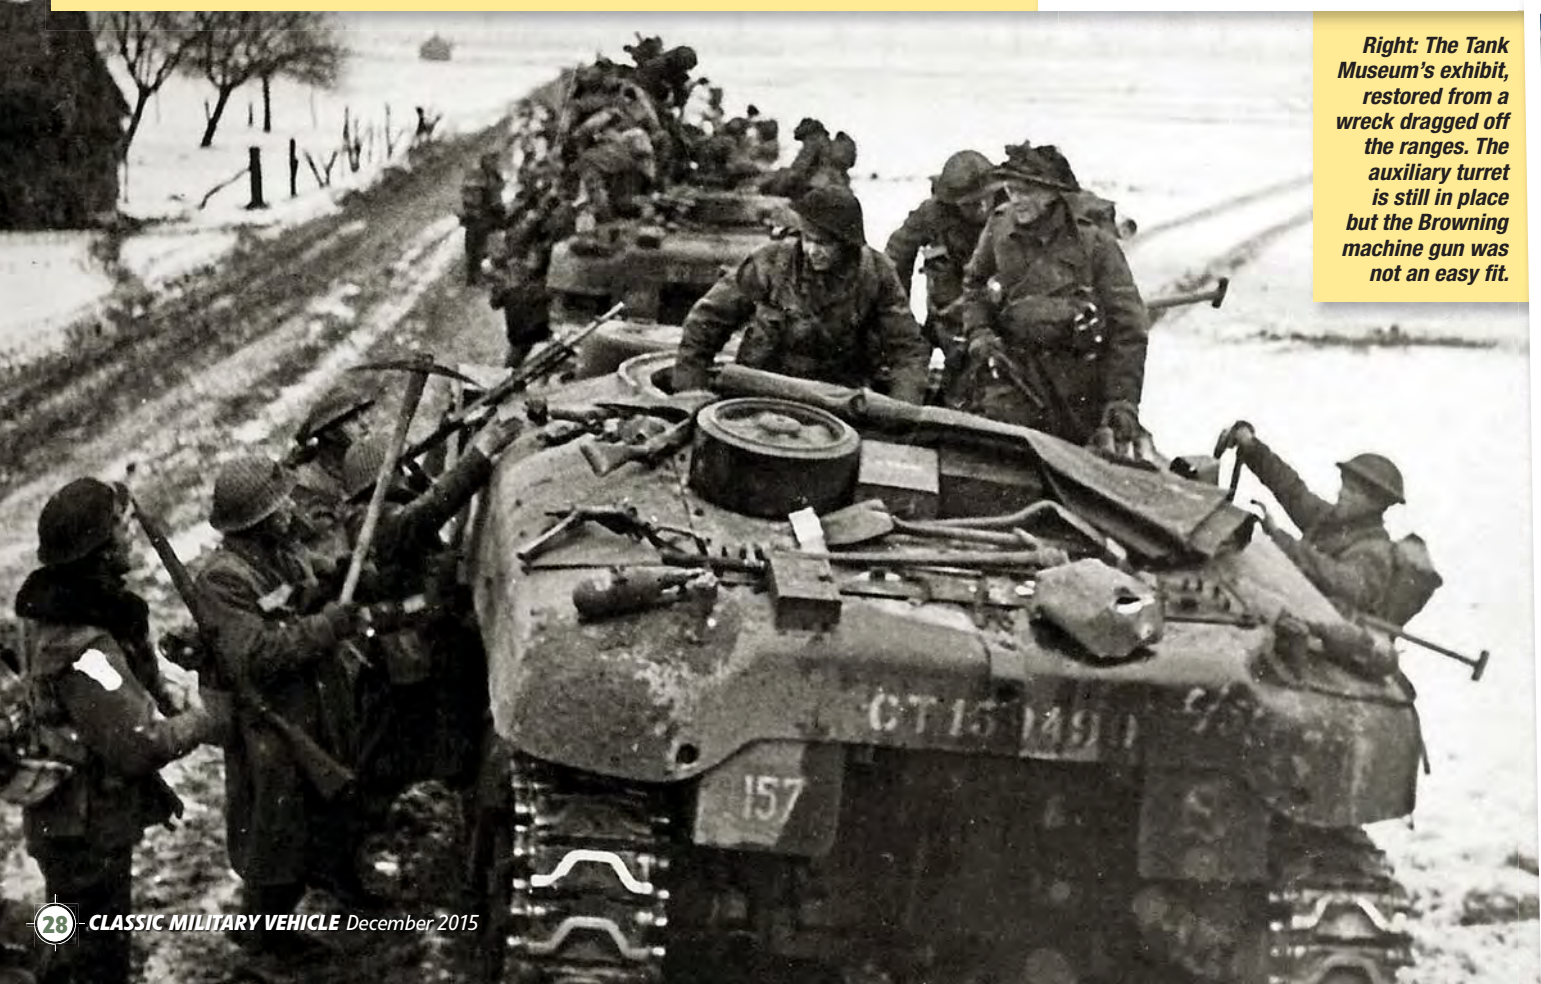
Right: The Tank Museum's exhibit, restored from a wreck dragged off the ranges. The auxiliary turret is still in place but the Browning machine gun was not an easy fit.

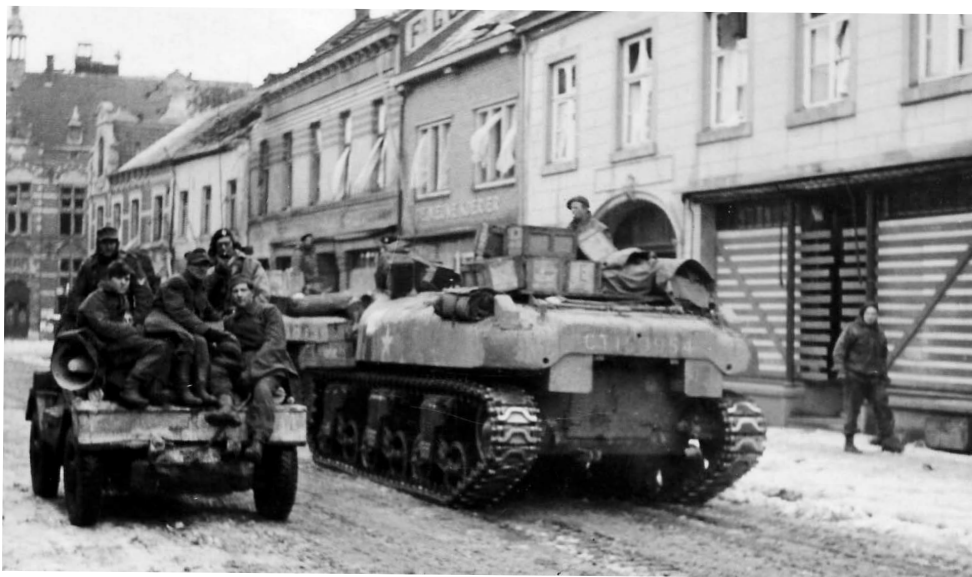
Heavily laden Kangaroos, perhaps in the supply role, in a snowy street. The Daimler Dingo passing the other way is rather overloaded. It seems to be carrying German prisoners and has what looks like a loudspeaker on the side.

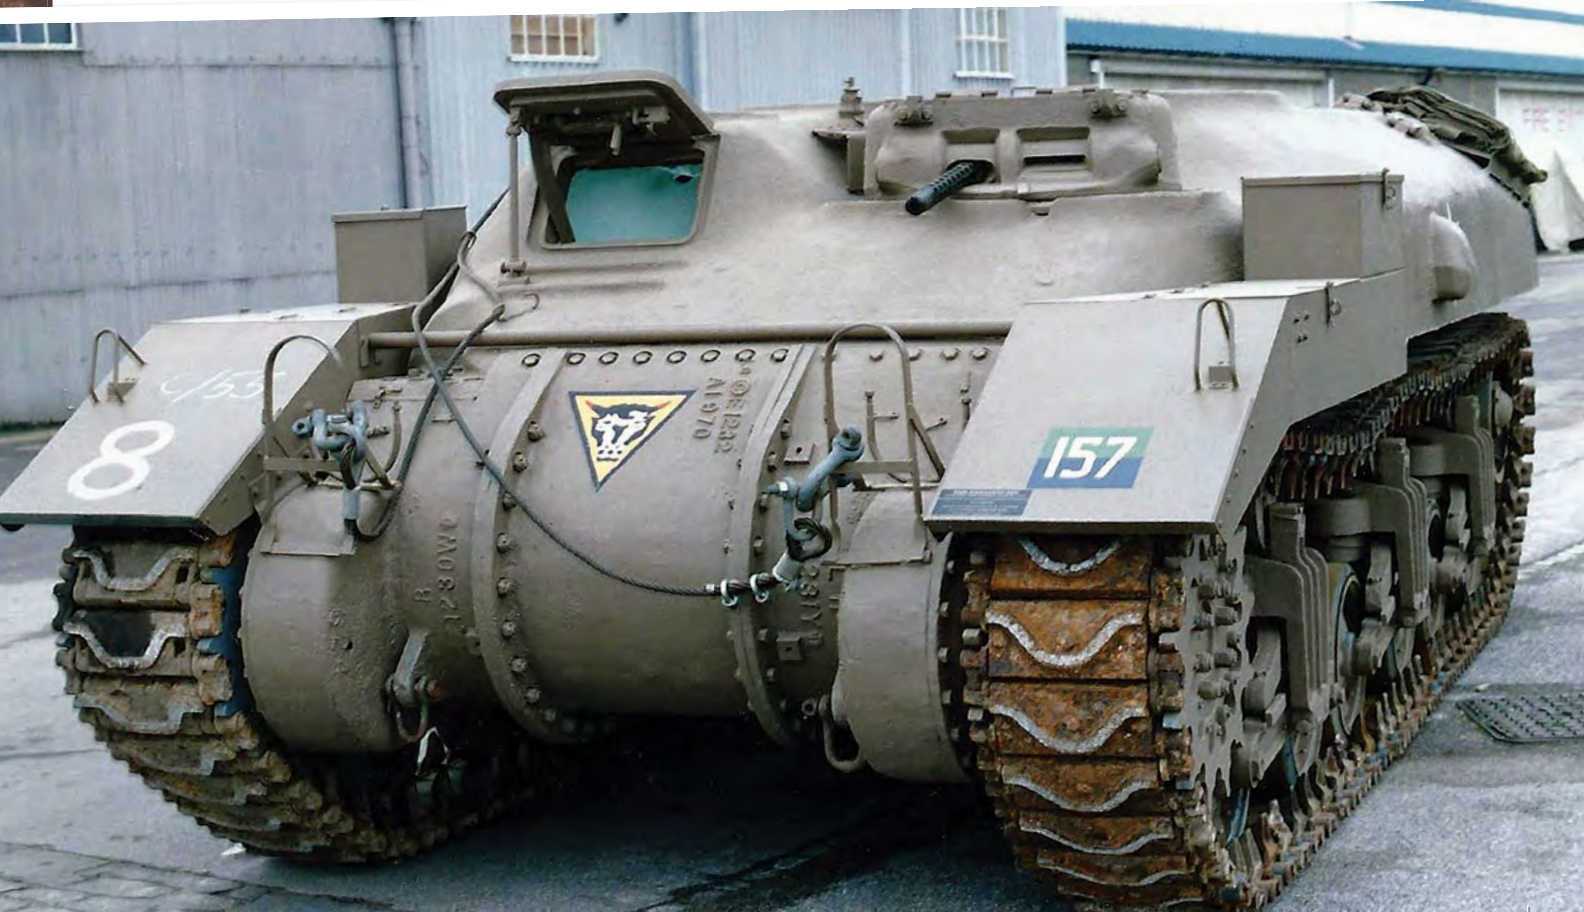
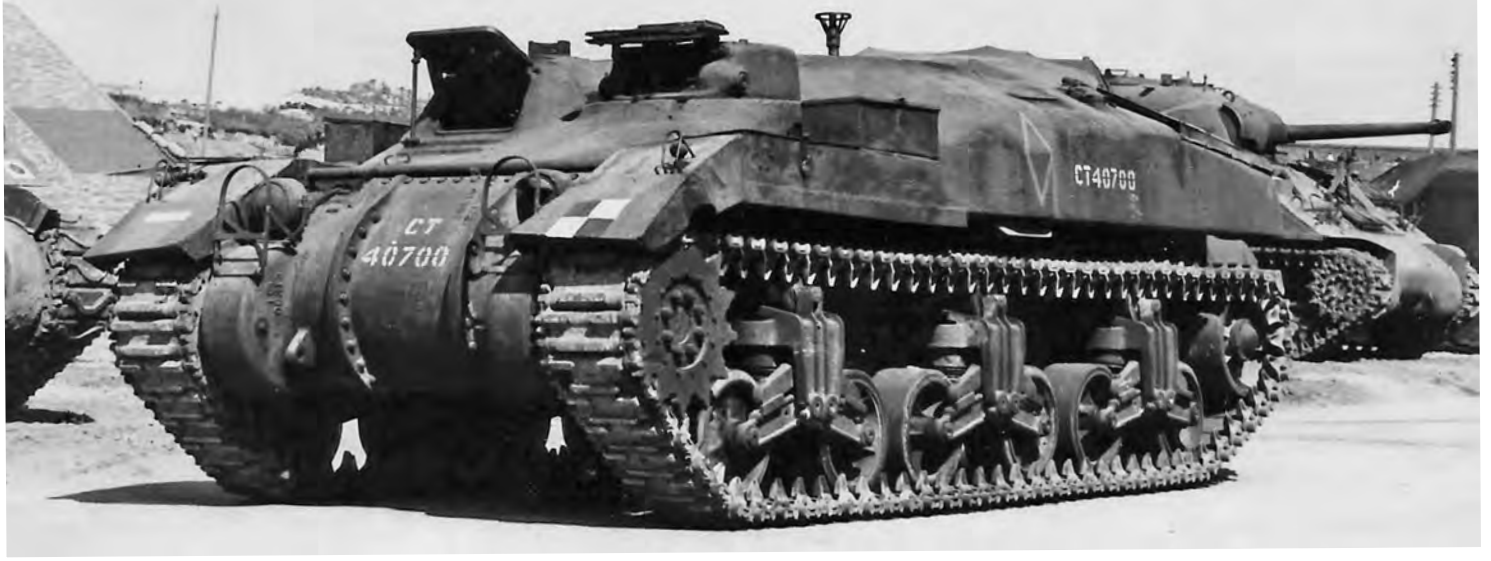
This photograph of a turreted RAM Kangaroo in a tank park is almost certainly post-war.

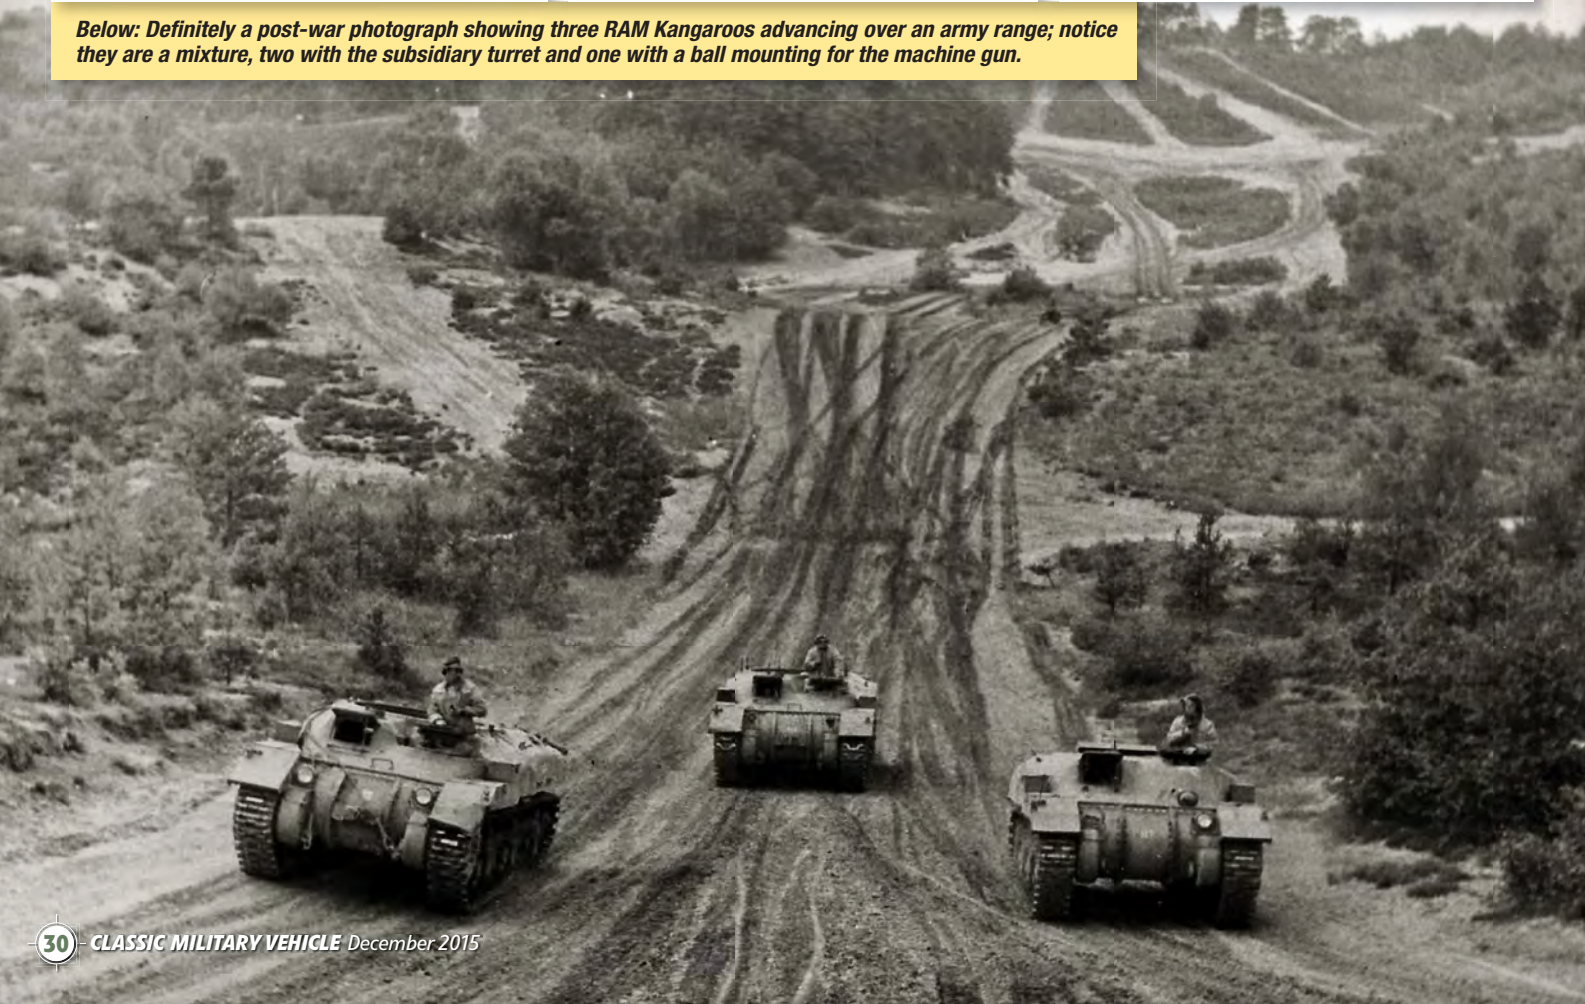
Below: Definitely a post-war photograph showing three RAM Kangaroos advancing over an army range; notice they are a mixture, two with the subsidiary turret and one with a ball mounting for the machine gun.
