Lehigh Valley International Airport (ABE)

Airside Pavement Management Plan

Final Working Report – February, 2018

Prepared by
Airport Design Consultants Inc.

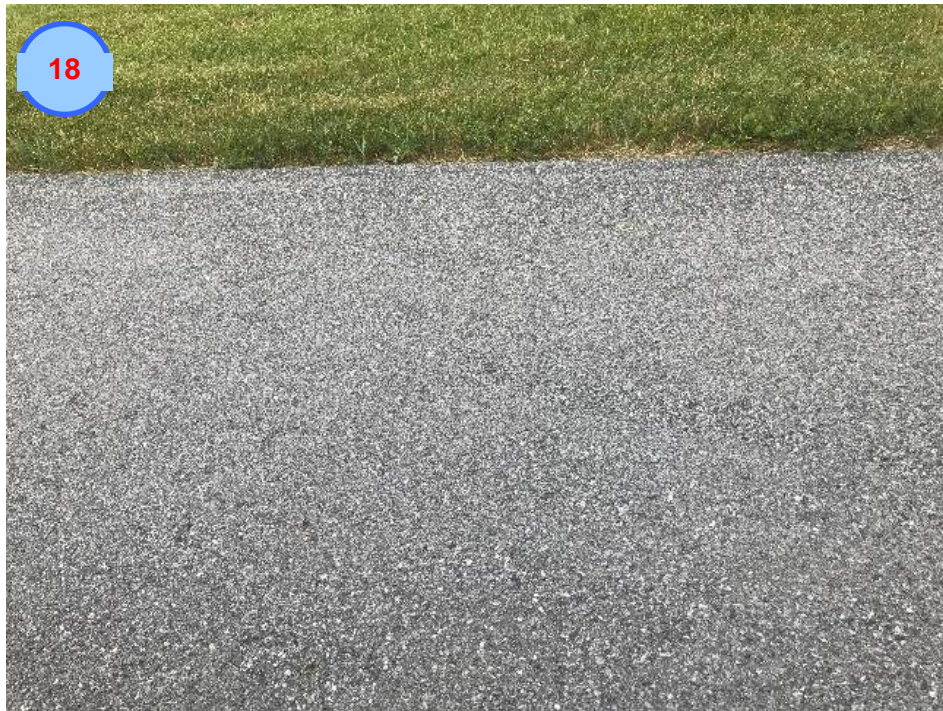
18

Weathering

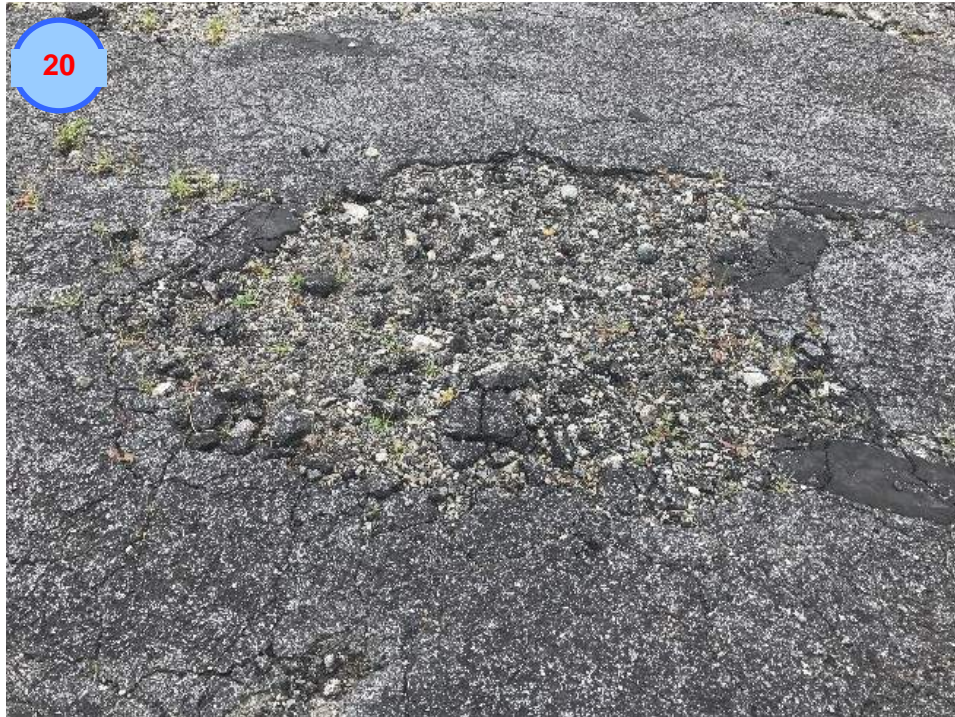
Depression, Raveling

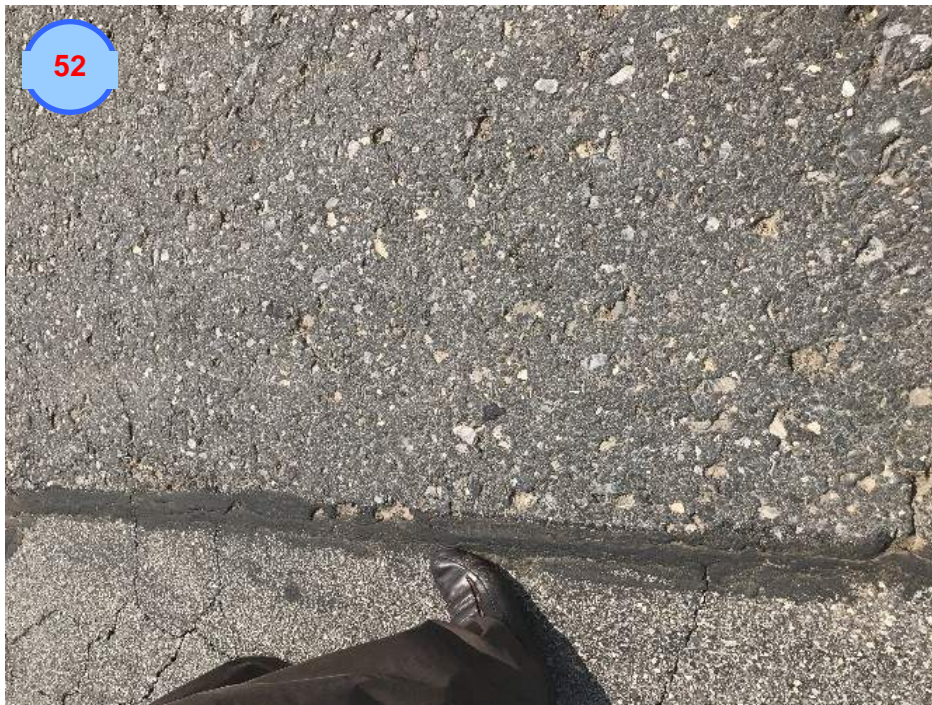
Weathering East Section

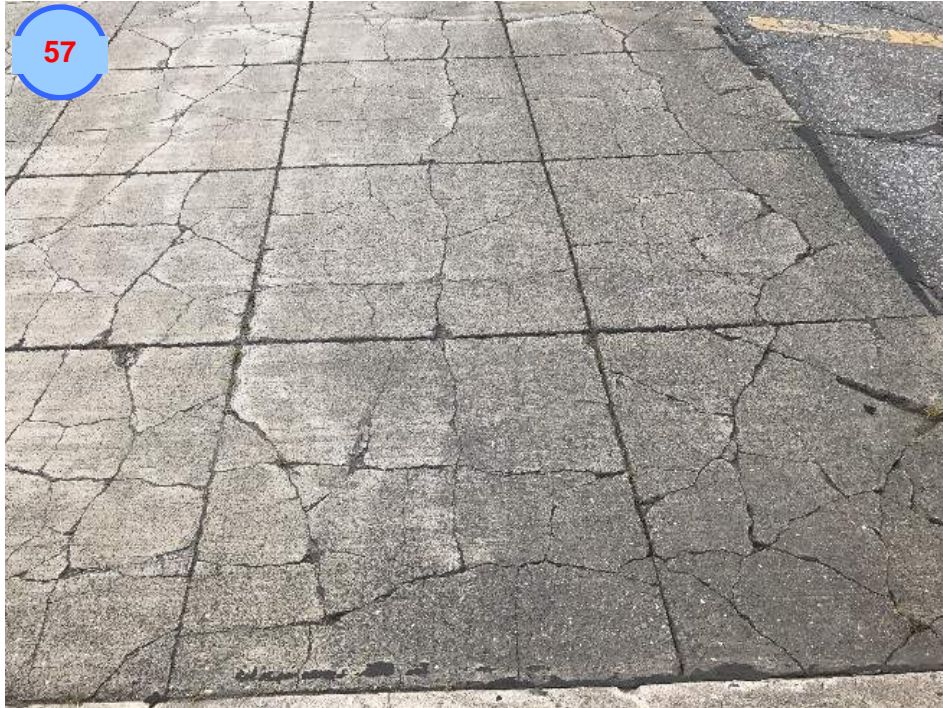
Shattered Slabs East Section-PCC

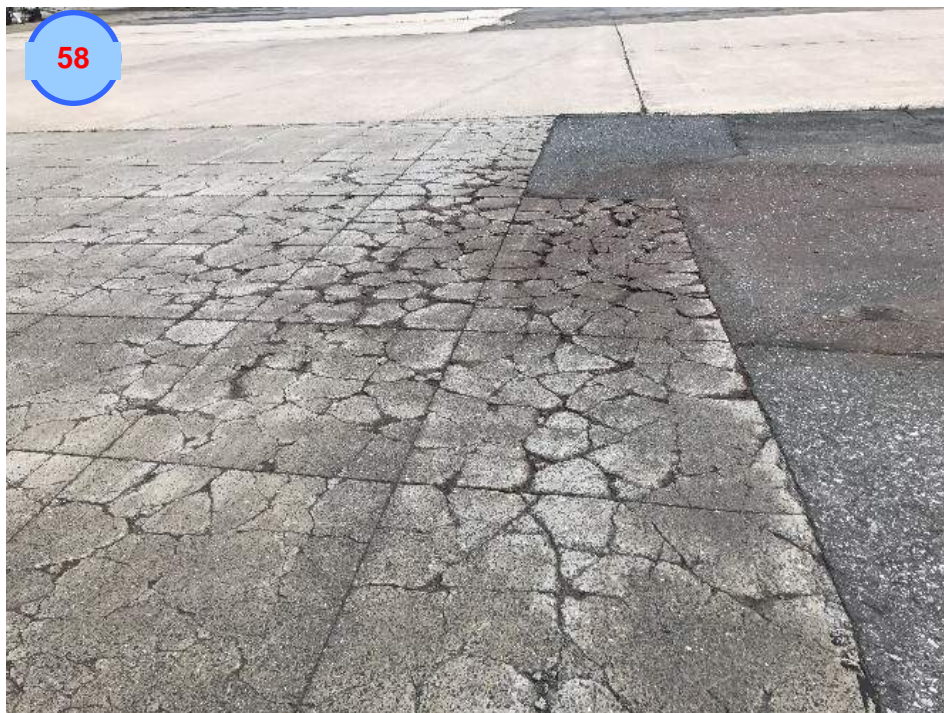
Shattered Slabs- East Section PCC
